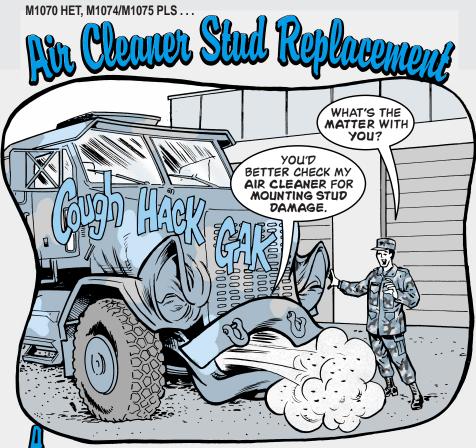
ir cleaner assemblies for M1070 HET and M1074 and M1075 PLS tractors are not cheap, so it's tough to replace one just because a mounting stud is damaged or missing.

But, if the assembly doesn't seal correctly, the truck engine can be damaged, and that can be even more expensive.

So, keep the seal between the air cleaner mount and the element container tight by using stud replacement kit, NSN 5307-01-456-6938.

The kit contains one stud, one retainer and one washer. Order as many kits as you have damaged or missing studs.
